LAKE LEFFERTS DAM

PHASE I INSPECTION REPORT NATIONAL DAM SAFETY PROGRAM

NJ 00089

JULY 1978

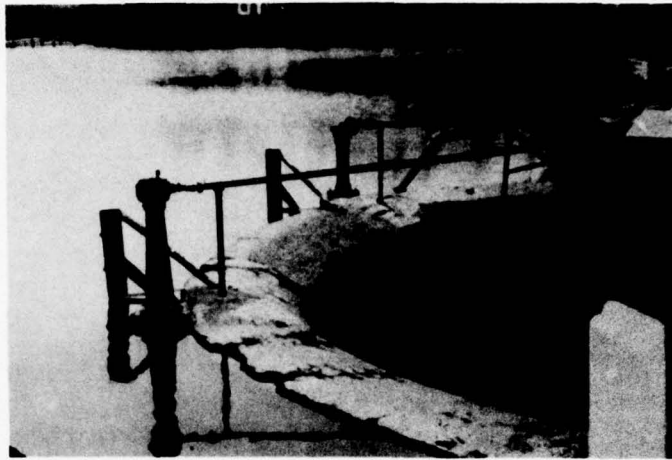
The top of the spillway crest is eroded, with some steel reinforcing bars exposed. The crest is not fully level, and variations of up to 1.5 inches are detectable. Minor horizontal and vertical cracking was visible on the downstream face. There is some local spalling of concrete adjacent to the right low level outlet.

Photo 1 - View of semi-circular concrete spillway weir abutting the reinforced concrete spillway bridge structure over Matawan Creek; the low level outlets are operated by crank extensions from the side walk (see Photo 5)

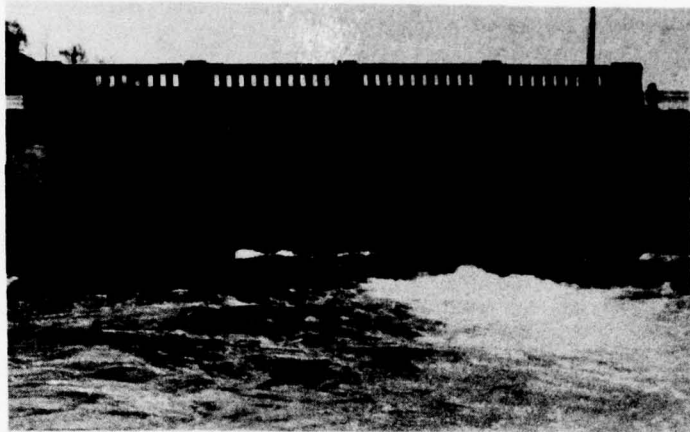
There was some leakage (approximately 20 gpm) from each sluice gate, however, the flow should have no detrimental effects.

Photo 3 - View of the downstream face of the spillway bridge over Matawan Creek; the concrete spillway is in back; the right low level outlet is fully open; discharging water strikes the left bridge abutment before continuing downstream; Matawan Creek is tidal and the picture was taken near high tide

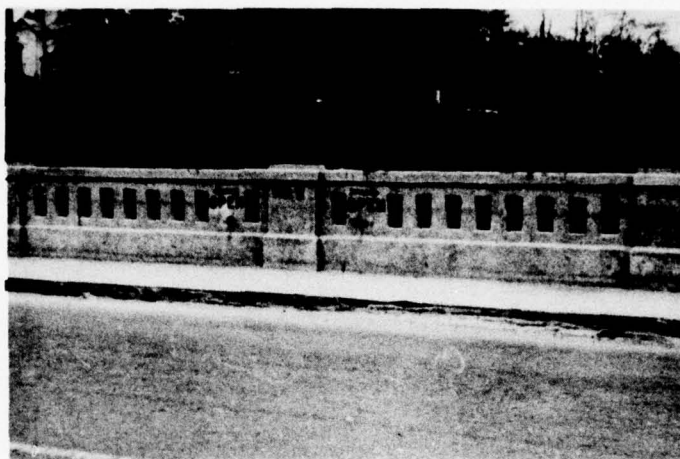
universal joint (Hooke's type) to an extension shaft. The extension shafts allow the sluice gates to be operated from the surface of the roadway which bridges the spillway. The universal joint on the 24-inch valve is worn and is quite loose. In addition, the support guide for the extension shaft has broken loose from the concrete spillway. In its present condition, this gate cannot be operated with any reliability. These items should be replaced. The other operator and extension shaft for the 30-inch diameter valve is in good condition.

Photo 5 - View of the upstream spillway bridge railing, where the low level outlet gate crank extensions pass through

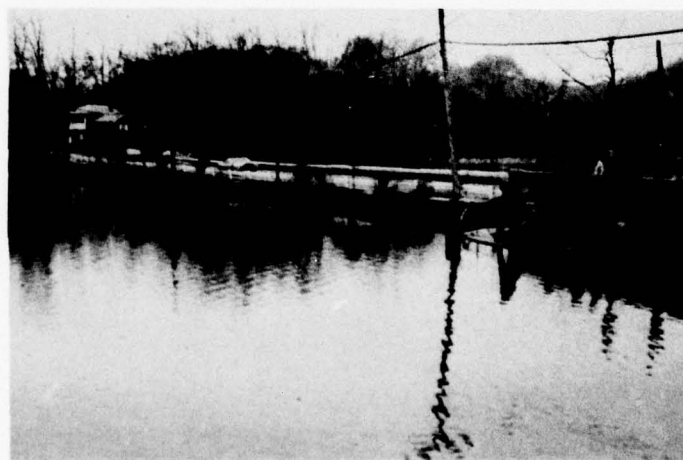
There is no evidence of leakage or seepage at this time. The upstream timber bulkhead sheeting is in good condition, for the portion visible above the lake level.

Photo 6 - Upstream view of the left abutment embankment and upstream timber sheeting

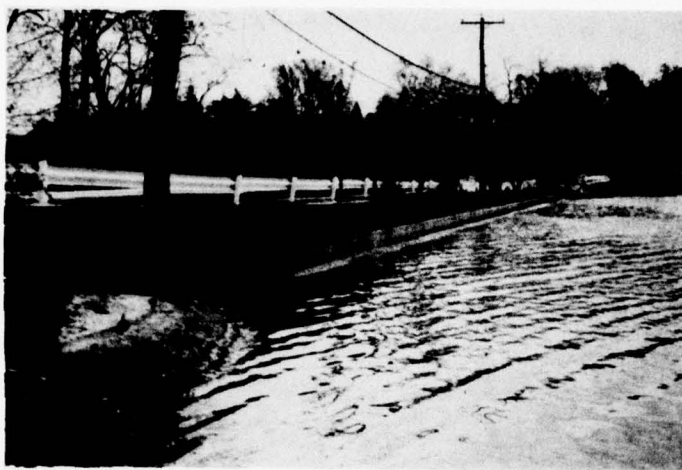
The condition of the abutments are good, there is no significant cracking, and the concrete surfaces are in acceptable condition. There is some local surface spalling visible on the downstream face. The upstream left parapet wall is leaning into the pool. The bridge superstructure is in acceptable condition.

Photo 7 - View of the left upstream face of the abutment
and embankment looking toward the right abutment

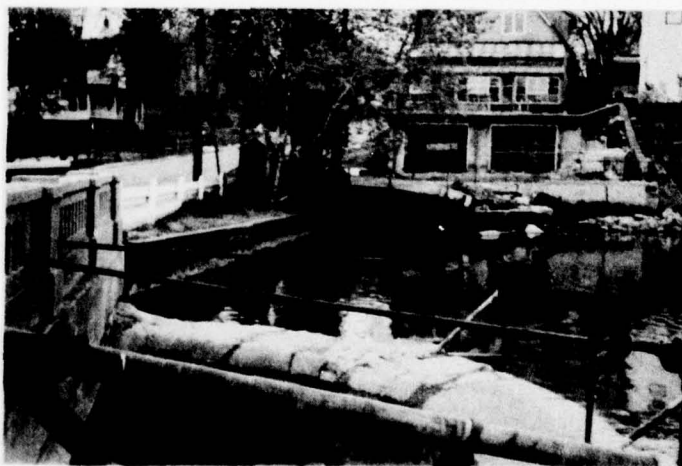
Photo 8 - View of the right upstream face of the embank-
ment and right abutment

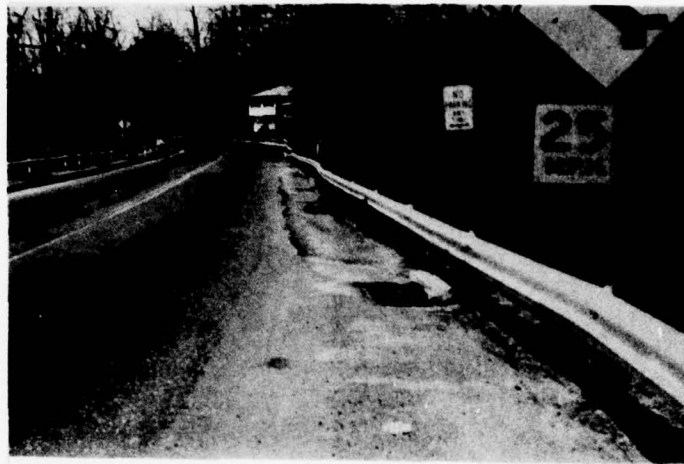
VISUAL EXAMINATION OF	OBSERVATIONS	REMARKS OR RECOMMENDATIONS
SURFACE CRACKS	Top of roadway embankment impounding Lake Lefferts is called Ravine Drive. Black top paving show a crack parallel to dam axis at a point where downstream face of retained embankment has moved from 6 to 12 inches downstream.	Monitor roadway cracking with a semi-annual inspection.
UNUSUAL MOVEMENT OR CRACKING AT OR BEYOND THE TOE	The timber pile supported downstream face of the left embankment has moved from 6 to 12 inches downstream, deflecting the vertical timber piles and punching down the batter piles. Area of movement is 125 to 200 feet to left of bridge.	Monitor deflections at half yearly intervals.
SLOUGHING OR EROSION OF EMBANKMENT AND ABUTMENT SLOPES	The area downstream of the left abutment timber pile supported embankment face is poorly graded, and retains normal drainage. Erosion at base of wall is believed to be due to roadway embankment overtoppings. Timber retaining walls are all in good condition.	Regrade downstream area of left embankment to drain water away from base of retaining wall.

VERTICAL & HORIZONTAL ALIGNMENT OF THE CREST	The embankment is a county road and is on a vertical grade. The horizontal alignment of the downstream left embankment face has moved downstream from 6 to 12 inches.	
RIPRAP FAILURES	NA

Photo 9 - View of the roadway forming the dam crest, looking toward the left abutment; the guardrail on the downstream face has moved with the timber pile supported downstream retaining wall; the roadway paving has cracks paralleling the dam axis, also indicating downstream movement

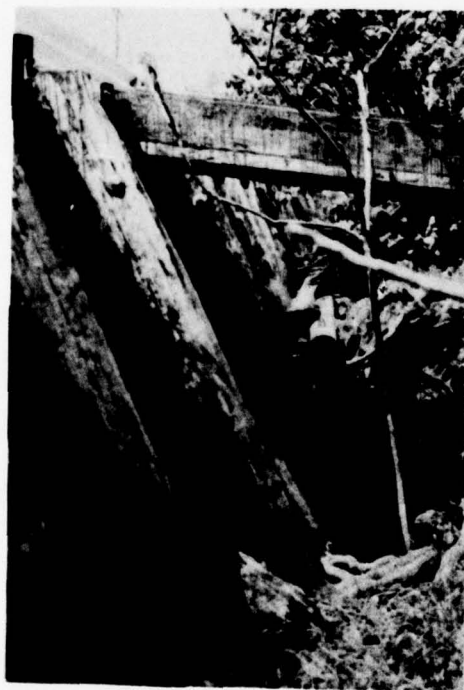
Photo 12 - Close-up of the downstream timber pile supported retaining wall; the wood structure visible at the top of the wall is a roadway drainage trough

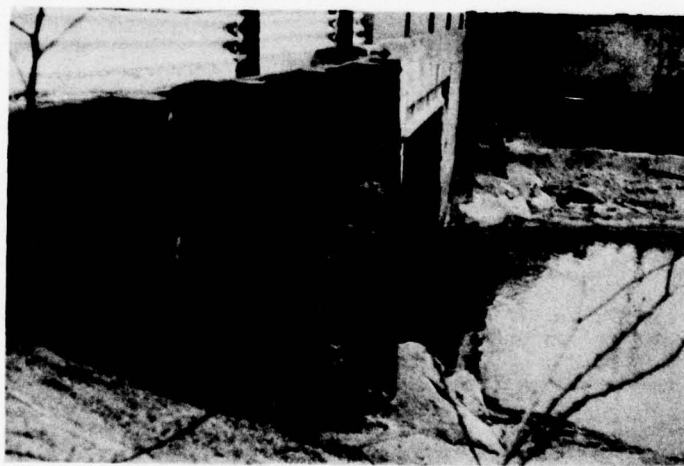
Photo 14 - Timber wingwall connecting the concrete bridge
to the right abutment embankment

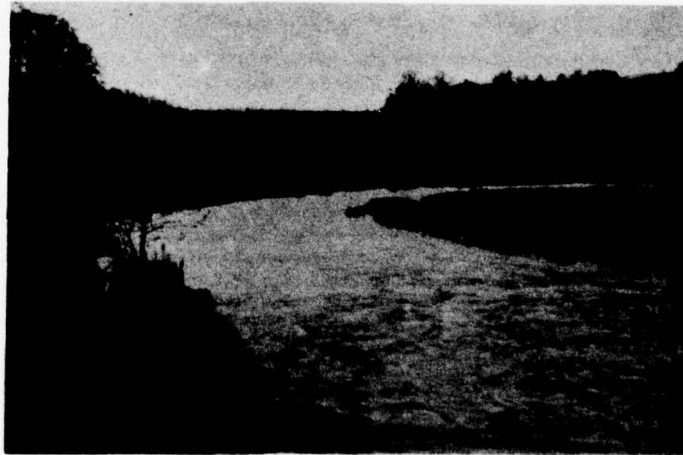
Photo 16 - Downstream channel of Matawan Creek, taken near high tide with the right low level outlet fully open; end of channel riprap is visible on the left

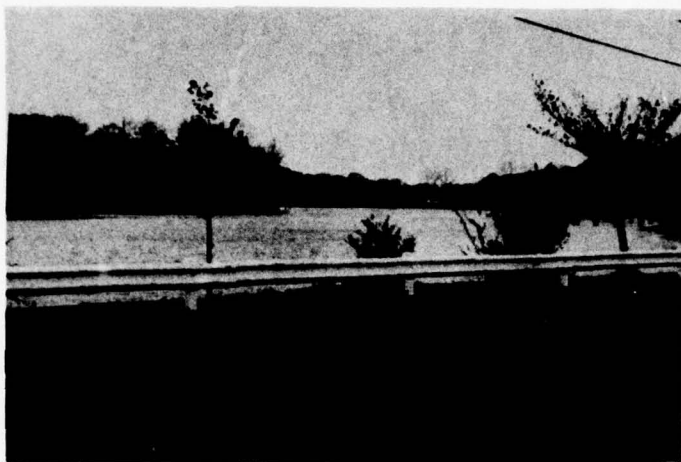
Although silting has been observed on the upstream end of the lake, it has not progressed far enough to significantly affect the validity of the hydrologic computations made. The 24-inch diameter low level outlet is currently not considered operable, and should be restored to use immediately to enhance the control of overtopping.

Photo 17 - View of Lake Lefferts, looking upstream from the roadway embankment

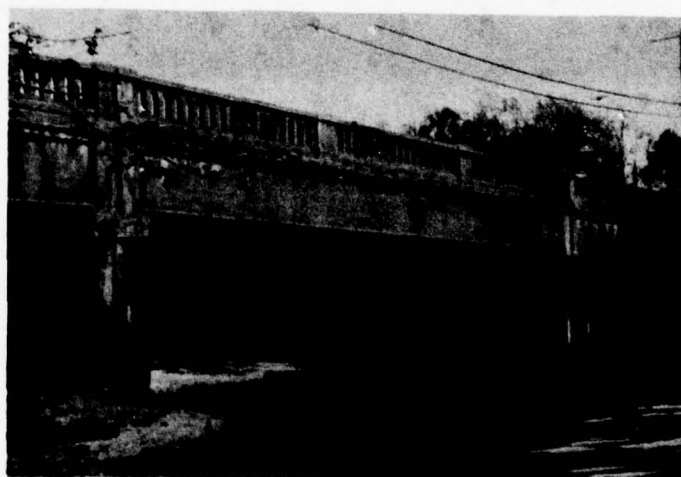
Photo 18 - State Route 34 crossing Lake Lefferts. 2,500 ft. upstream of dam embankment at Ravine Drive
